D&D of a Former Beryllium Machine Shop

Gary E Whitney, CIH
Industrial Hygiene & Safety Division
Los Alamos National Laboratory

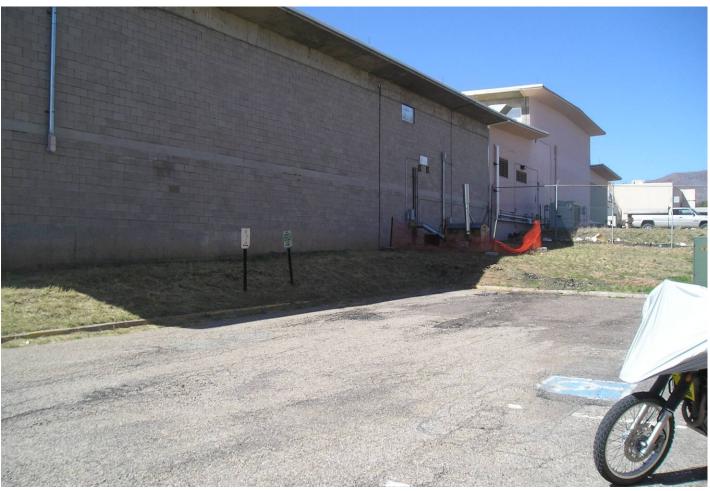
Exterior Wall of Shop

- Major security concern for limited area.
- A lot of work to come up with a plan that met all security requirements, was feasible to build, and would suit the purpose for which it was intended.
- Location must be selected, the area prepared, door fabricated, materials positioned, work scheduled, and everything ready to go before any wall penetration can be made.
- Must be installed and secured in one day unless guards are stationed.

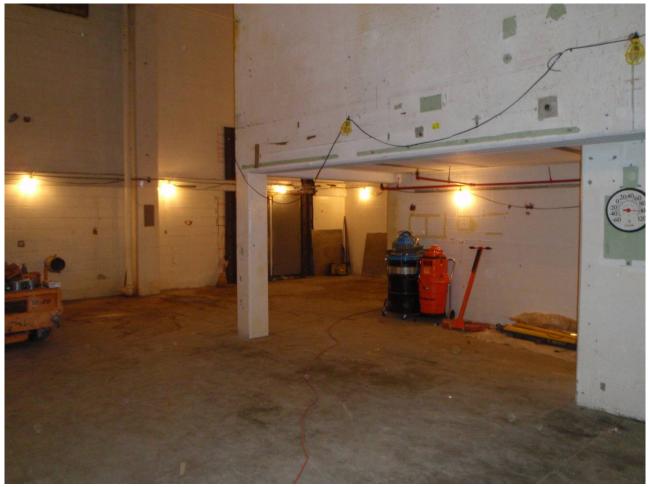
Significant Hazard: Heat Stress
